600 Palmerston Avenue, Toronto, Ontario

SUMMARY INSPECTION REPORT

PROPERTY: 600 Palmerston Avenue, Toronto, Ontario

INSPECTION REPORT

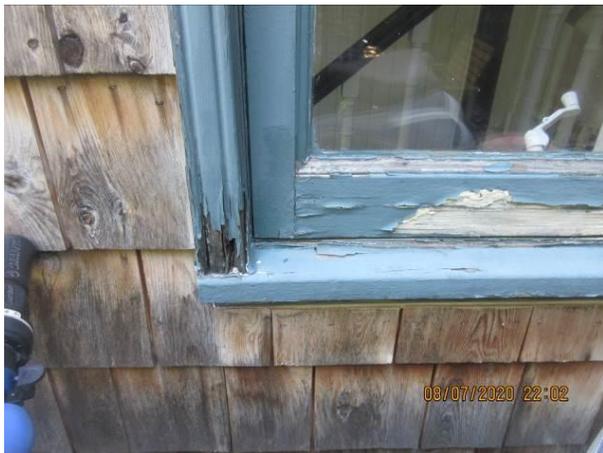
G: there is localized rot to some of the window frames on the rear main floor extension. Repairs and painting maintenance are required. The double door set off the kitchen are deteriorated, including failure of one of the thermal glass panels. Consider replacing this set of doors.

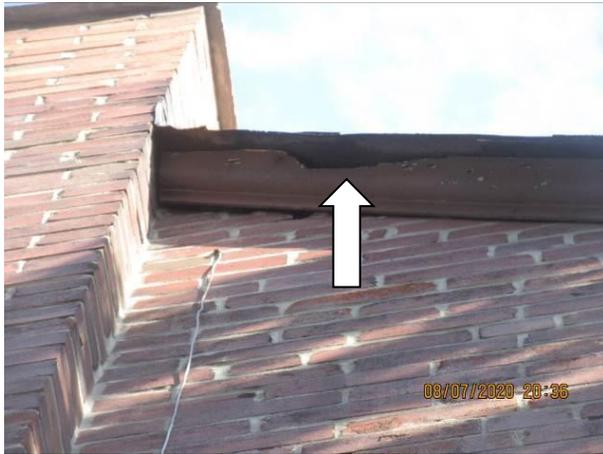
P: there is a hole in the wood trim below the 3rd floor shingles at the southeast corner as a result of past wildlife activity. Repairs are required (typically made with wire mesh).
